# SOFTWARE EVOLUTIONS OF THE VOICE OVER WLAN SOLUTION FOR OMNIPCX OFFICE

This document describes the evolutions of software versions available for the Voice over WLAN solution and the software compatibilities between all Alcatel-Lucent WLAN equipments.

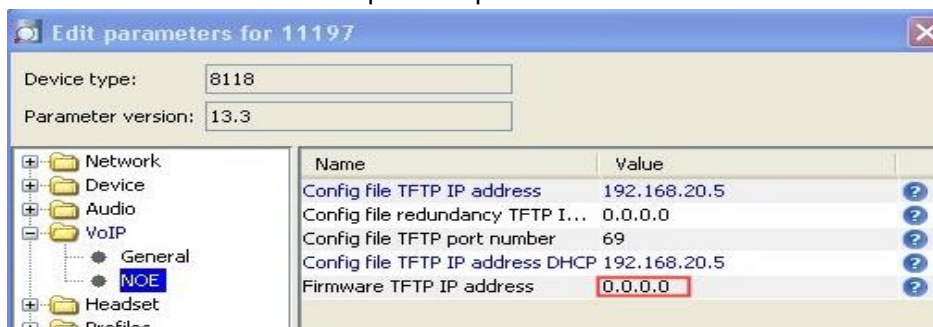
The WinPDM tool permits to update the Omni Touch 8118/8128 WLAN handset's version. In that case, 0.0.0.0 must be configured in the Firmware TFTP IP address field available from WinPDM VoIP > NOE sub-menu of the handset in order to avoid update request to another TFTP Server.
